Strength Degradation of Filament-Wound Graphite/Epoxy Tubes Due to Either Impact Damage or Fabrication Defects

1 August 2004

D. J. CHANG and H. A. KATZMAN
Space Materials Laboratory
Laboratory Operations

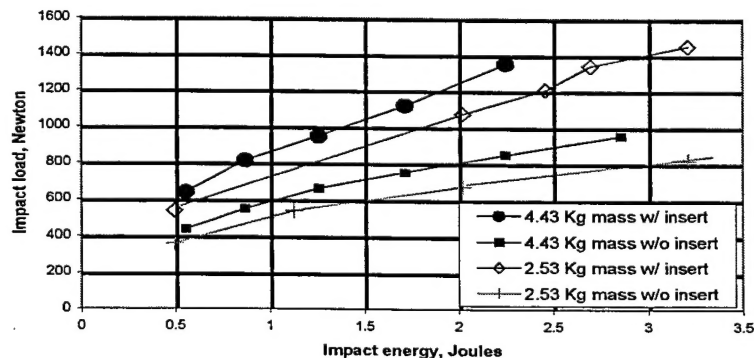
Figure 5 depicts the impact load vs. impact energy plot using two different masses, 2.53 and 4.43 kg (5.57 and 9.75 lb). It shows that a tube filled with nearly incompressible polymeric material experiences an impact load as much as 50% more than that for an unfilled tube for the same incident energy.

Figure 5. Impact load versus impact energy with and without incompressible polymeric insert (two impact masses).
